New York State Department of Transportation

Yellow Flag NB22CTW014

BIN: 1065318

Feature Crossed: 6TH AVENUE

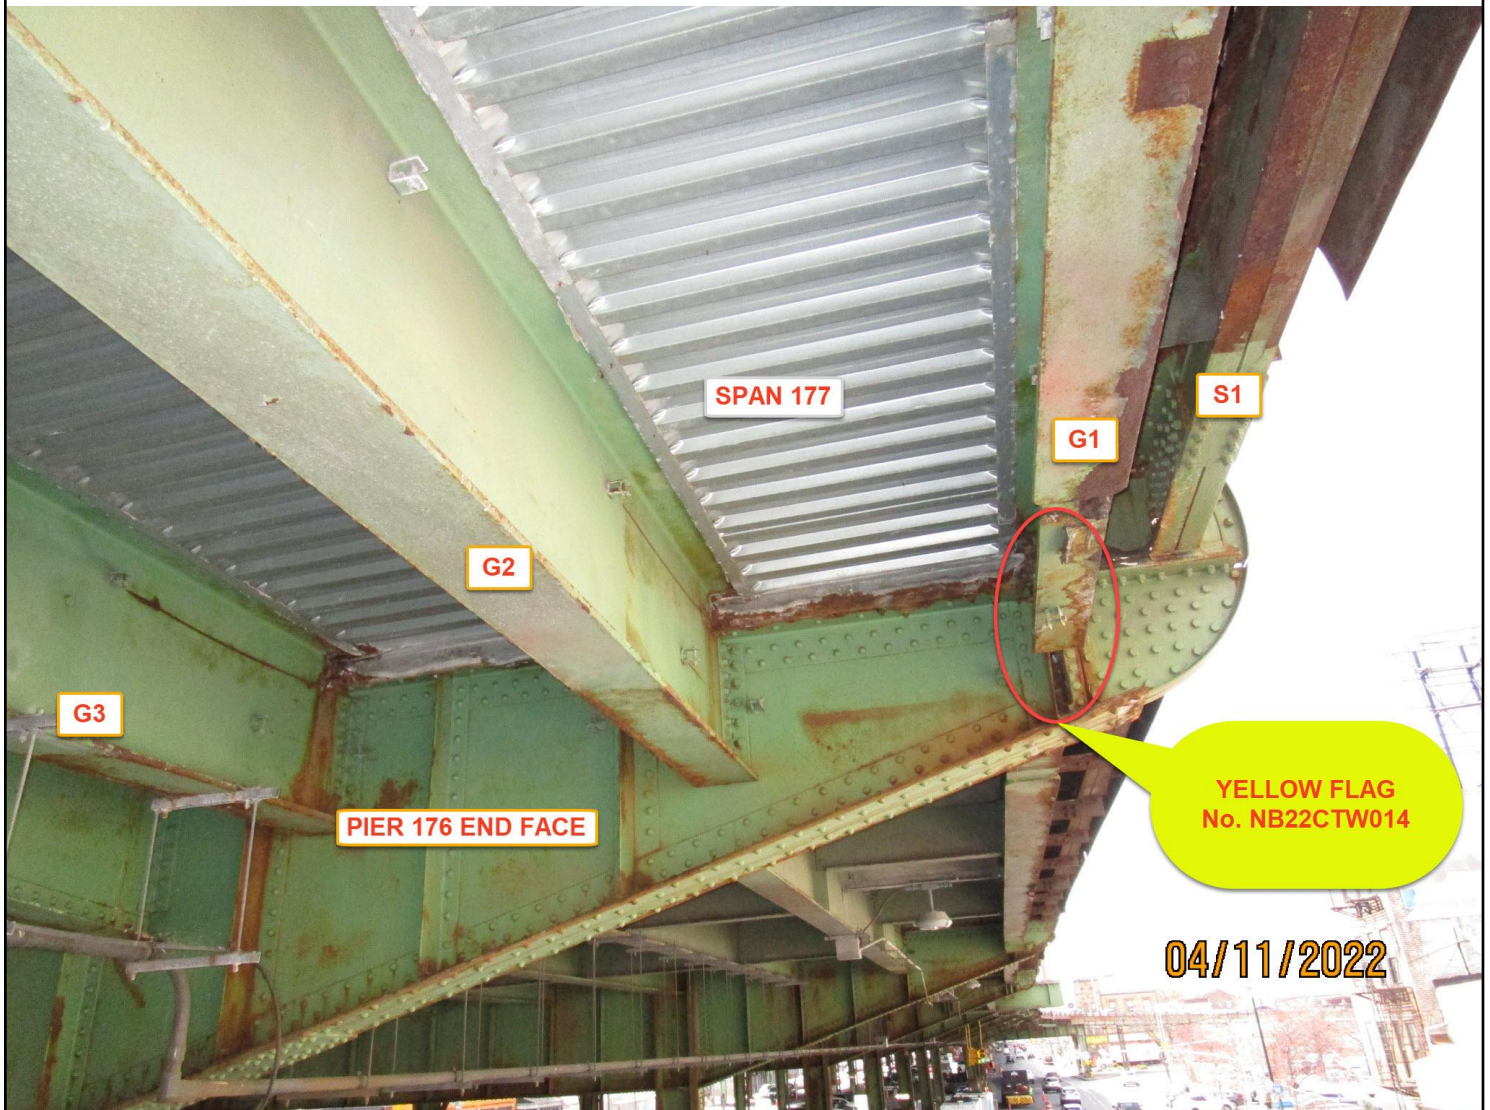
Photo Number: 1

Attachment Description: General view of the flagged condition at Girder G1 in Span 177 at Pier 176. Looking Begin.

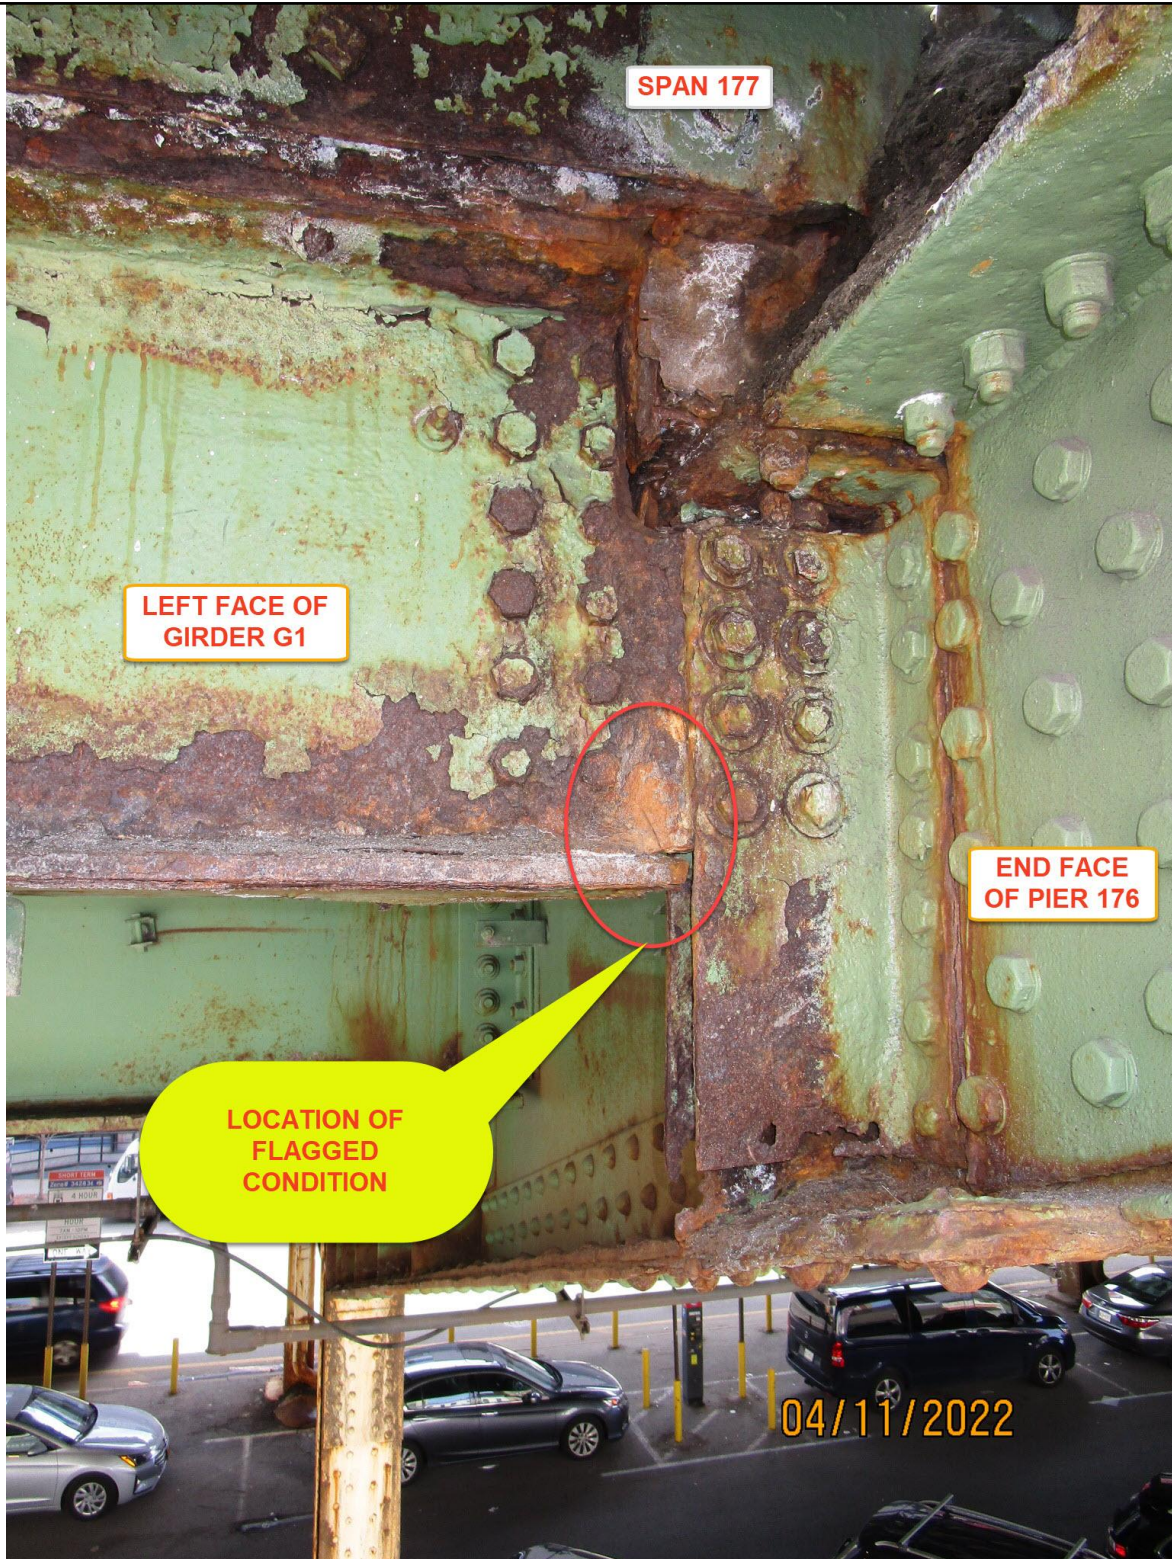
Photo Number: 2

Attachment Description: Close up general view of the flagged condition at Girder G1 in Span 177 at Pier 176. Looking Right.

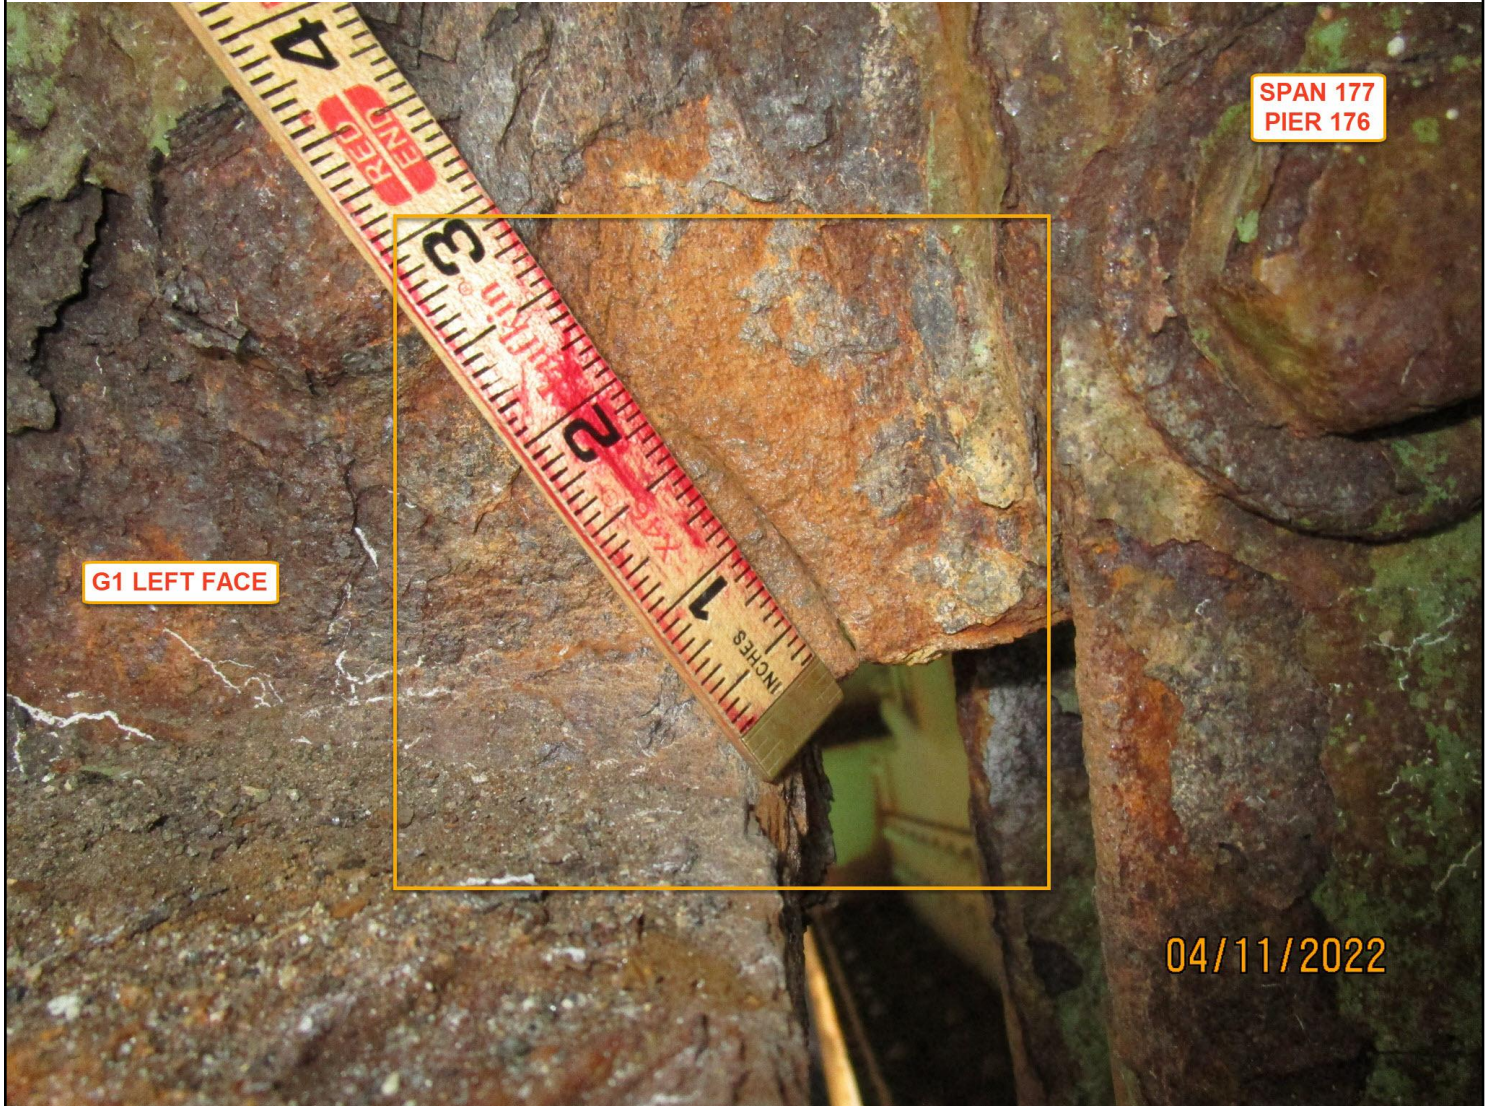
Photo Number: 3

Description: The end of Girder G1 in Span 177 at Pier 176 exhibits 1-5/8" long diagonal crack in the girder web stemming from the bottom of the bottom cope of the girder. This condition is the same as reported in the last inspection. The girder is framed into the web of the pier.

Attachment Description: The left face of Girder G1 in Span 177 at Pier 176. The girder exhibits 1-5/8" long crack in the web stemming at the bottom cope of the girder. Looking Right.

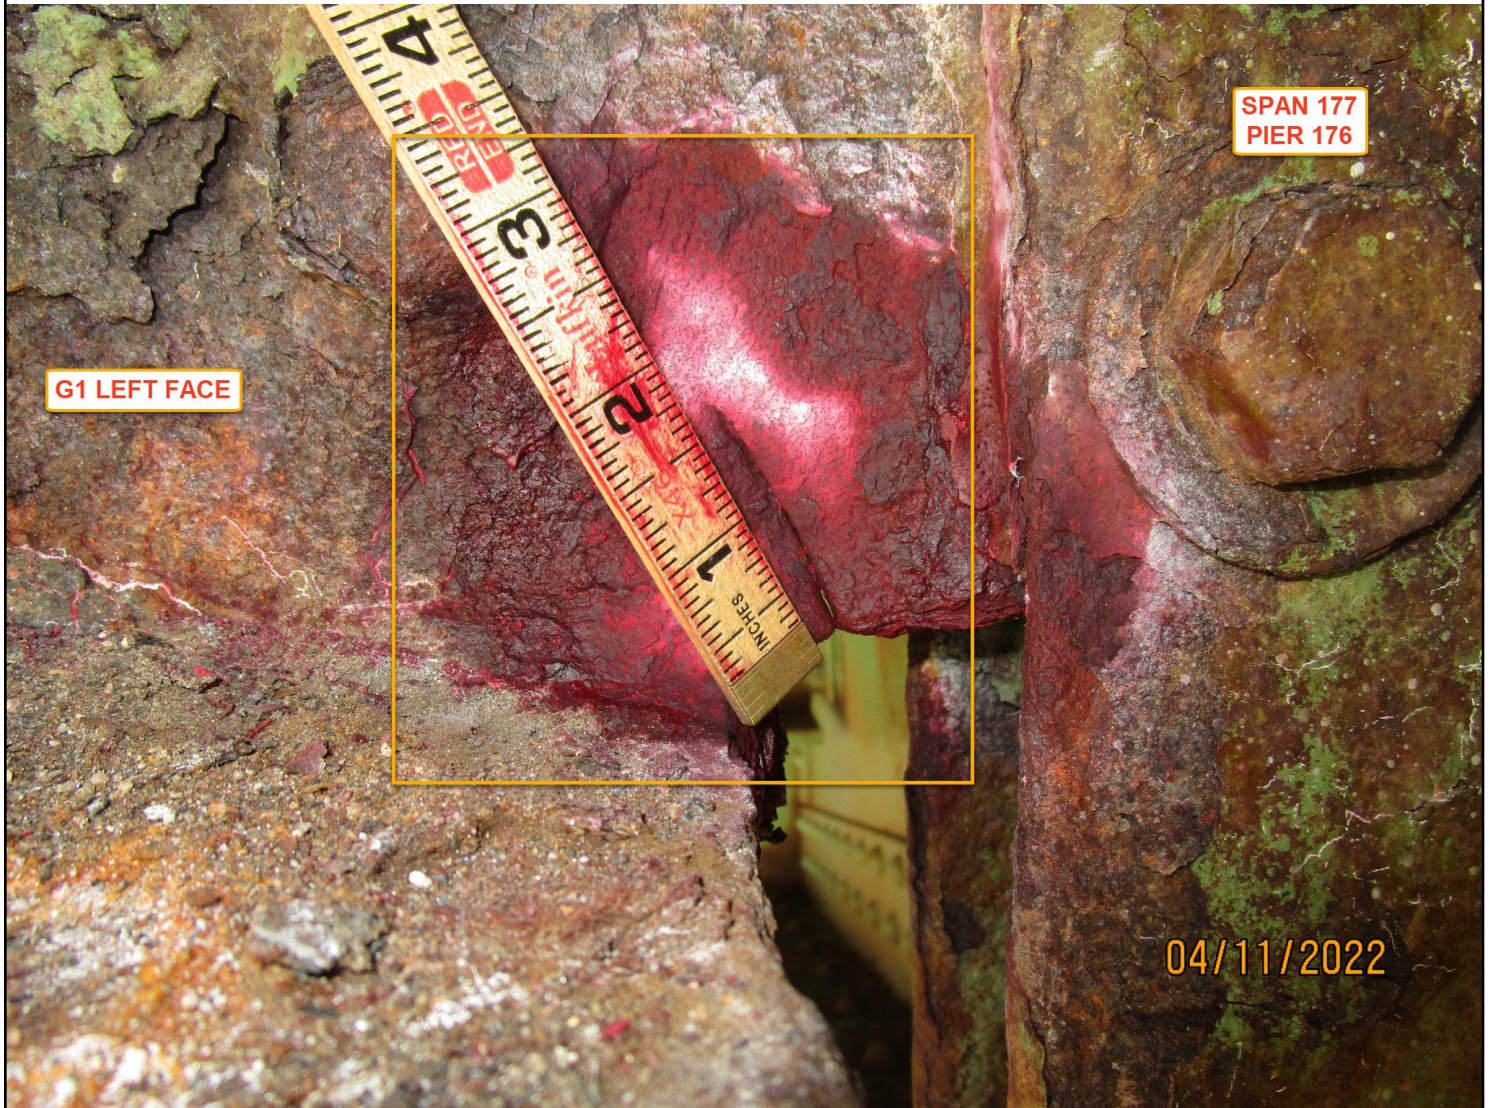
Photo Number: 4

Attachment Description: The left face of Girder G1 in Span 177 at Pier 176. The girder exhibits 1-5/8" long crack in the web stemming at the bottom cope of the girder, after dye penetrant test. Looking Right.

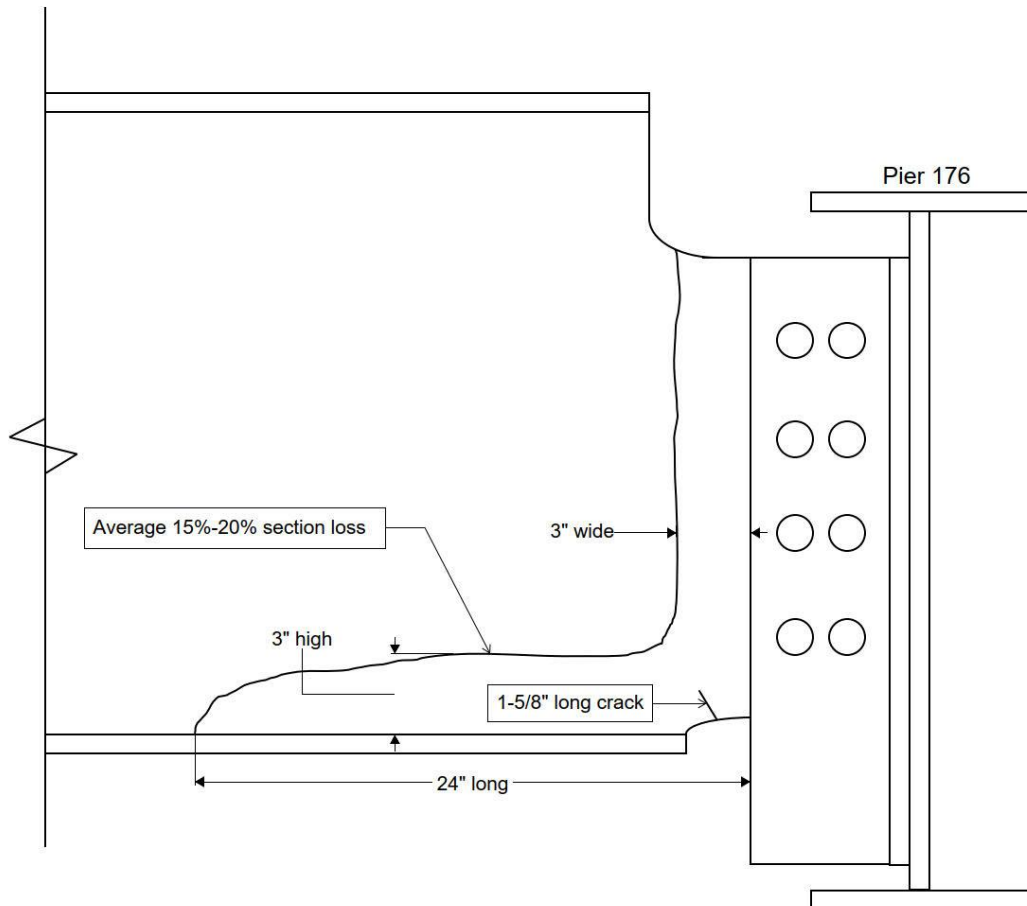
Left Face of Girder G1 Sketch in Span 177 at Pier 176

-The defects at the bottom of the connection angles are not shown since they are not relevant to the flagged condition at the girder.
